Repair of a fractured implant overdenture gold bar: A clinical and laboratory technique report

Fahim Vohra¹, Amani Al Fawaz¹

Key words: Dolder bar, implant-supported overdenture, soldering

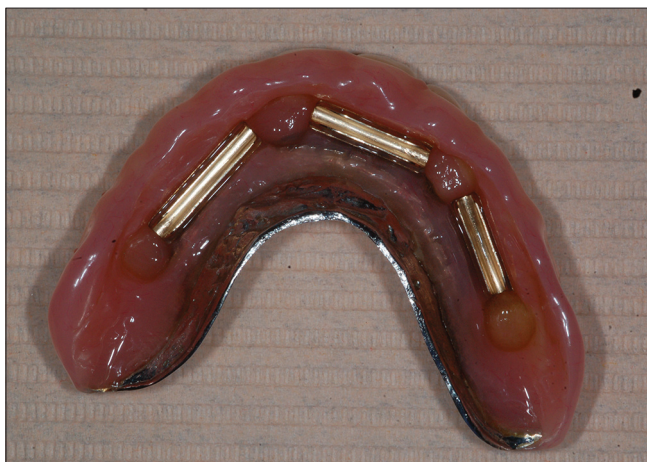
Figure 1: Intaglio surface of the metal framework reinforced maxillary implant overdenture with reduced palatal coverage showing three metal riders

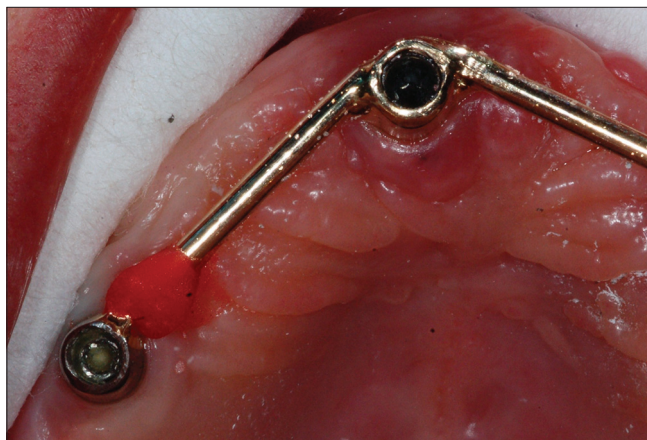
Figure 3: Intra-oral splinting of the fracture ends using chemical cured pattern resin (Duralay, Reliance Dental Mfg. Co.)

2. Intra-orally, the fracture was initially stabilized using sticky wax (Sticky wax, Ainsworth Dental Company, Marrickville, Australia) and fixated using chemically cured inlay pattern resin (Duralay, Reliance Dental Mfg. Co, Worth, Illinois, USA). Employing the bead-on method, both the ends of the fracture line and few millimeters beyond was covered by the pattern resin [Figure 3].

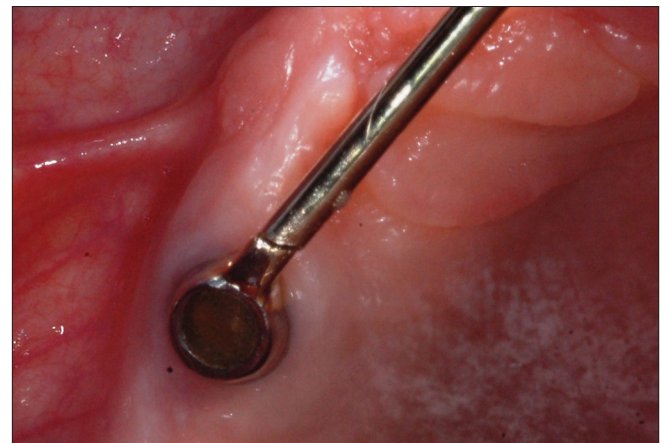
1. Complete seating of the gold copings on the implant platform was verified using periapical radiographs after the screws were torqued at 30 Ncm. The fracture on the Dolder bar, which was approximately 4 mm mesial to the coping on the most distal left maxillary implant, was found to be undisplaced [Figure 2].

Figure 2: Gold bar fracture mesial to implant coping at tooth position no. 24, near the solder joint

the outcome of inherent weakness of the metal alloy, inadequate dimensions and design of the bar retainer, magnitude of occlusal forces and the antagonist^[16] (fixed, removable prosthesis or natural dentition), inferior solder joints,^[17] and fatigue failure.^[18] The fracture was located at the solder joint mesial to the left distal maxillary implant coping. Repeated complain of loose bar retainer and soft tissue inflammation indicates incomplete seating of the coping on the implant platform,^[19,20] i.e., a non-passive implant coping connection. Also, a diagonal discrepancy in approximation of the fracture line was observed, reinforcing the potential for non-passive fit. The problem was compounded further by comparatively apical placement of left distal maxillary implant. The continuous stress at the implant/coping connection due to non-passive fit, apical position of implant, high occlusal forces, and inferior solder quality resulted in fatigue failure.

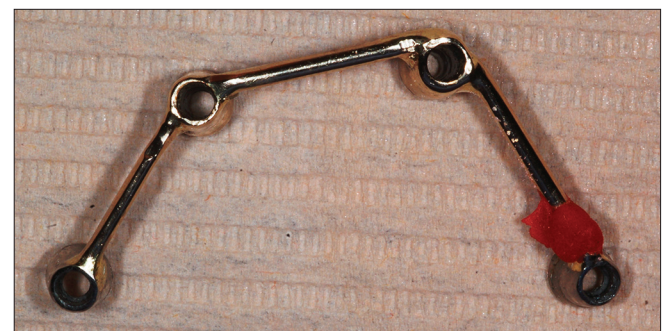
Figure 4: Splinted gold bar and coping assembly removed from the mouth to undertake laboratory procedure

3. Once the pattern resin had completely polymerized (5-7 minutes), the Dolder bar retainer was unscrewed and removed from the mouth using a SCS screw driver (Straumann, Basel, Switzerland) [Figures 4 and 5]. Regular neck healing abutments (Straumann 4.5Ø, 2 mm height)

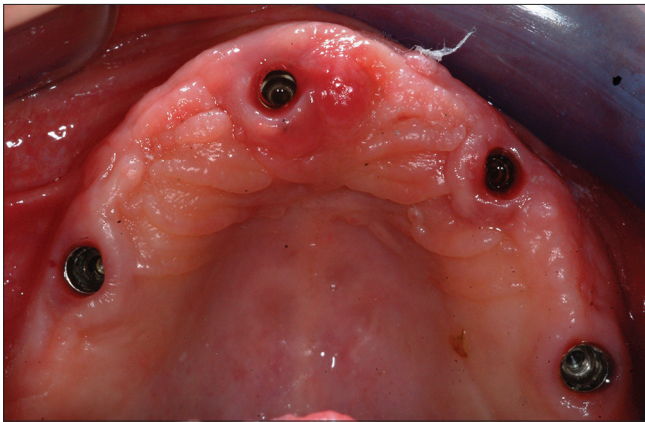
Figure 5: Intra-oral occlusal view of the maxilla after removal of the gold bar retainer

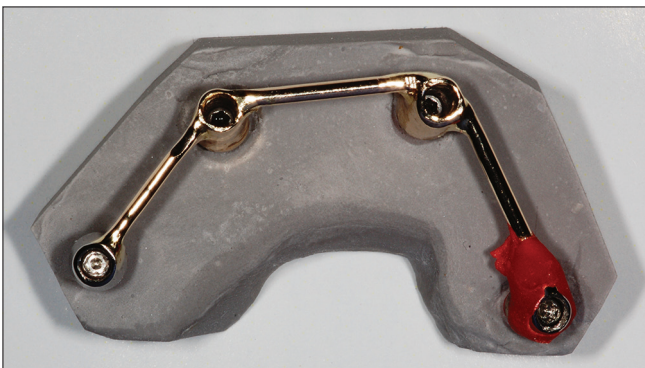
Figure 7: The gold bar retainer and implant analog assembly mounted in dental stone for positioning stability of fractured segments

4. Four implant analogs (Straumann RN syn Octa) were secured to the gold copings [Figure 6] on the overdenture Dolder bar, and the assembly was mounted in dental stone (Vel-Mix, Kerr Co, Orange, CA, USA) in the laboratory [Figure 7] to provide positioning stability.

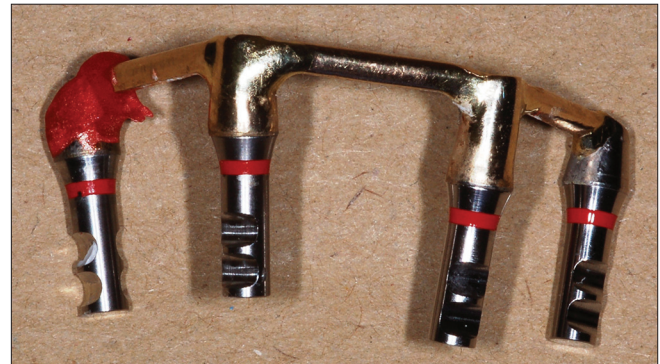
Figure 6: Compatible implant analogs (replica) secured to the gold copings on the bar retainer prior to mounting

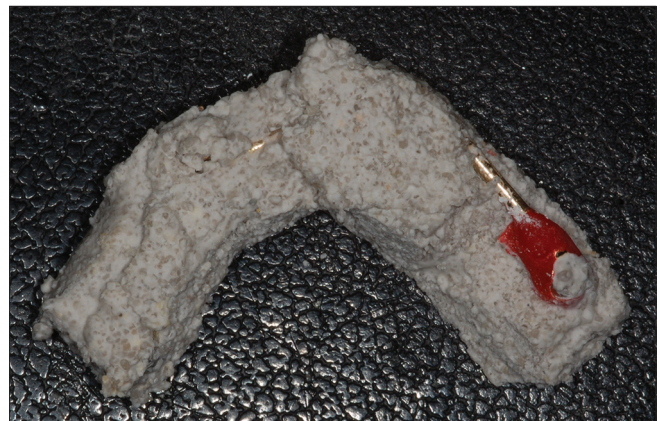
Figure 8: The mounted assembly of gold bar is invested (embedded in investment material), except the resin covered area around the fracture line for performing soldering

5. Next, the complete assembly was embedded in the solder investment material (Heravest L, Heraeus Kulzer, Germany) excluding the resin-covered portion [Figure 8].

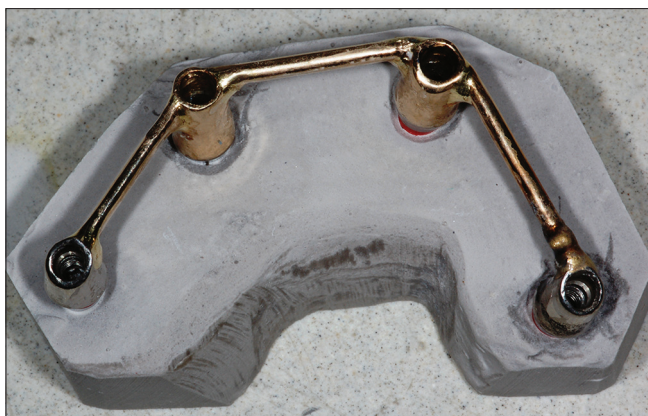
Figure 9: The soldered and divested gold bar assembly, prior to finishing and polishing

8. After bench cooling, the assembly is divested [Figure 9] using sandblasting and the gold solder was adjusted using coarse rubber disc and polishing was completed using a burlew/gold lustre blue disc (Shofu Dental Corp, St Marcos, CA, USA) [Figure 10].
9. The repaired bar and coping assembly was removed from the implant analogs and placed intra-orally after adequate disinfection and were found to connect passively on all four implants.
10. The maxillary implant overdenture prosthesis was stable on fit, and the patient was delighted with the excellent result. The repaired Dolder bar/gold coping assembly was fitted the same day, and the patient was able to wear a stable overdenture within just four hours.

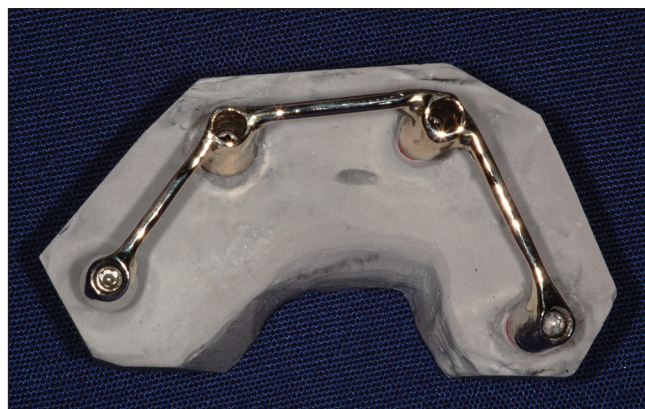
Figure 10: Repaired, finished, and polished gold bar retainer assembly, ready for intra-oral fit
